## Installation of the CHIP in the toner cartridge for Lexmark™ Optra™ T/Se

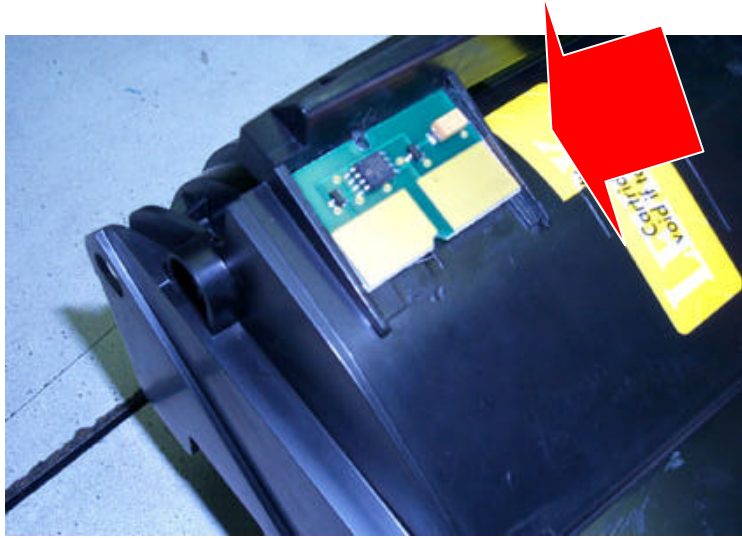
1. Remove the adhesive protection and press the sticky face against the plastic to ensure that the chip is properly attached.

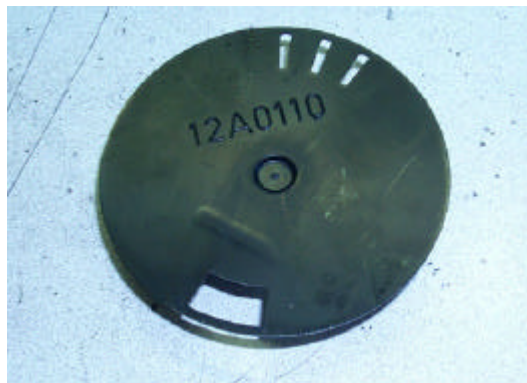
2. Please control that the encoder wheel is like this one
